SERVICE BULLETIN

SUBJECT: POSSIBLE EMERGENCY LOCATOR TRANSMITTER (ALERT 50)
ANTENNA GROUNDING

MODELS AFFECTED: M20C, S/N 20-1186 thru 20-1258
M20F, S/N 22-1306 thru 22-1438
M20J, S/N 24-0001 thru 24-0454

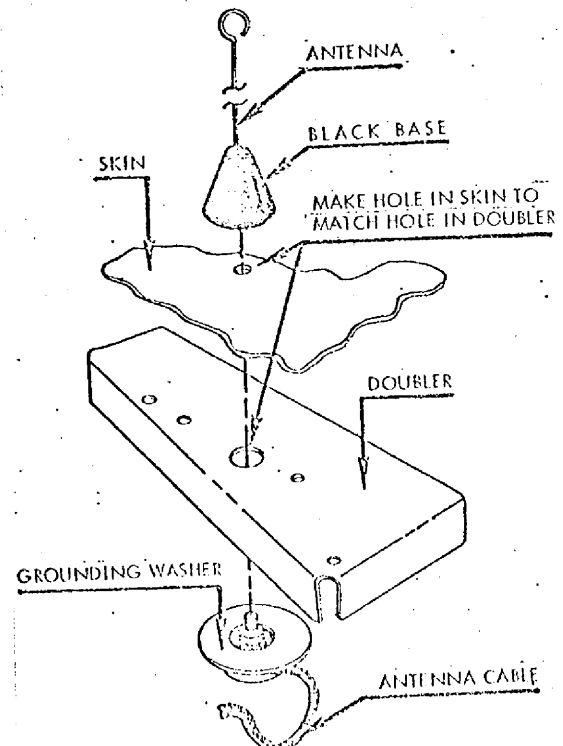
INTRODUCTION: It has been discovered that the ELT antenna mounting hole in the aircraft skin may be too small to allow proper insulation of the center stud. This could prevent the proper operation of the ELT signal in case of an accident. Therefore, it is MANDATORY that the following instructions be followed.

INSTRUCTIONS: Remove the ELT antenna by turning the black base counter-clockwise. Remove the antenna cable (stud) by pushing downward. Enlarge the hole in the skin to coincide with the matching hole in the doubler (approx. 1/2 inch). Apply zinc chromate to the raw edges of metal, being careful to remove any excess from the bottom of the doubler being contacted by the grounding washer of the antenna cable and attach the antenna by screwing the black base until secure. After installation seal underside with RTV-102 or equivalent to prevent water leaks.
