SERVICE INSTRUCTION M20-115A

SUBJECT:#1 TO ADVISE OWNERS OF PRECISION AIRMOTIVE LLC SERVICE BULLETIN NO. PRS-107 REV. 2 (ATTACHED)

Bulletin No.: PRS-107

SUBJECT: **HEX PLUG 383493 COMING LOOSE FROM REGULATOR COVER**

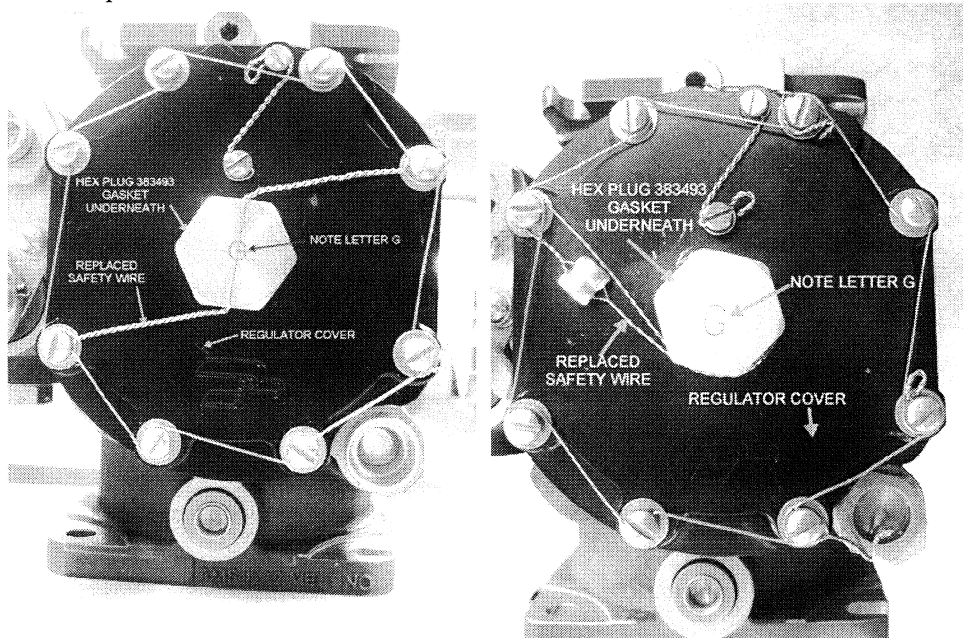
Note: The safety wire through the hex plug shown in the left hand photo is .025" wire wrapped around regulator screws under existing wire. It does not go through the holes in the screws. The safety wire through the hex plug shown in the right hand photo is .015" wire which passes through the regulator screw hole. This is the normal safety wire method used at the factory.

IMPORTANT: The letter "G" shown in the photos is to be stamped ONLY if the new gasket, part number 2577258 has been installed.

7. The hex plug must be safety wired with .015 or .025 inch diameter wire to the regulator cover as shown in the photos below. The wire shall pass thru the plug such that it pulls the plug in the tightened direction and does not rest on the corners of the hex on the plug (it is acceptable to wrap under the corners of the hex plug). These photos are just two examples of acceptable safety methods. Other safety methods such as those described in FAA AC 43-13 are also acceptable.

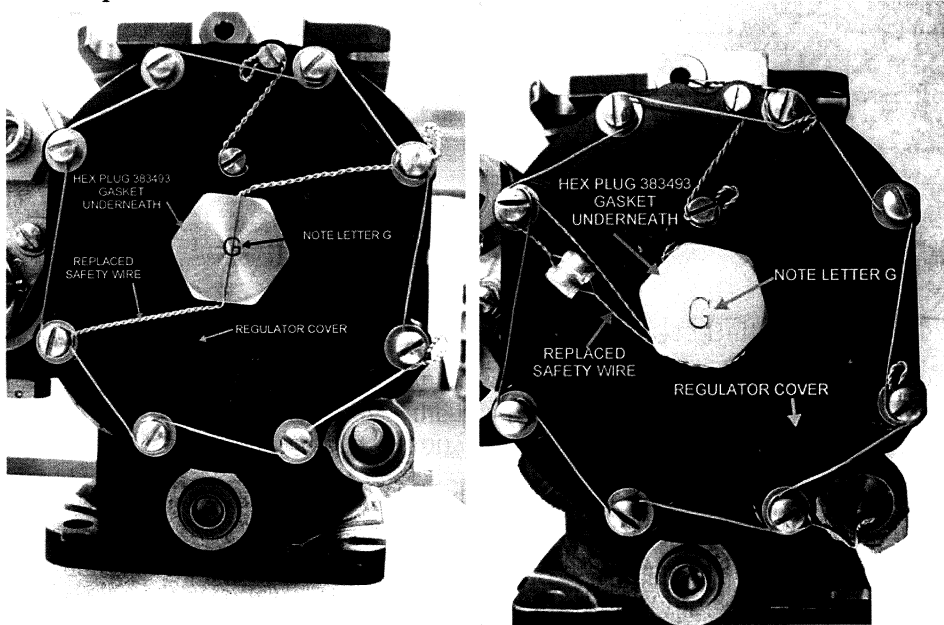
Note: The safety wire through the hex plug shown in the left hand photo is .025" wire wrapped around regulator screws under existing wire. It does not go through the holes in the screws. The safety wire through the hex plug shown in the right hand photo is .015" wire which passes through the regulator screw hole. This is the normal safety wire method used at the factory.

IMPORTANT: The letter "G" shown in the photos is to be stamped ONLY if the new gasket, part number 2577258 has been installed.

6. With an acceptable hex plug, an acceptable regulator cover, and an acceptable gasket, install the gasket over the hex plug and install plug into the regulator cover. Torque the hex plug to 90-100 in-lbs.
7. The hex plug must be safety wired with .015 or .025 inch diameter wire to the regulator cover as shown in the photos below. The wire shall pass thru the plug such that it pulls the plug in the tightened direction and does not rest on the corners of the hex on the plug (it is acceptable to wrap under the corners of the hex plug). These photos are just two examples of acceptable safety methods. Other safety methods such as those described in FAA AC 43-13 are also acceptable.
