**THIS BULLETIN IS FAA APPROVED FOR ENGINEERING DESIGN**

**SUBJECT: INSPECTION OF FUSELAGE TUBULAR STRUCTURE**

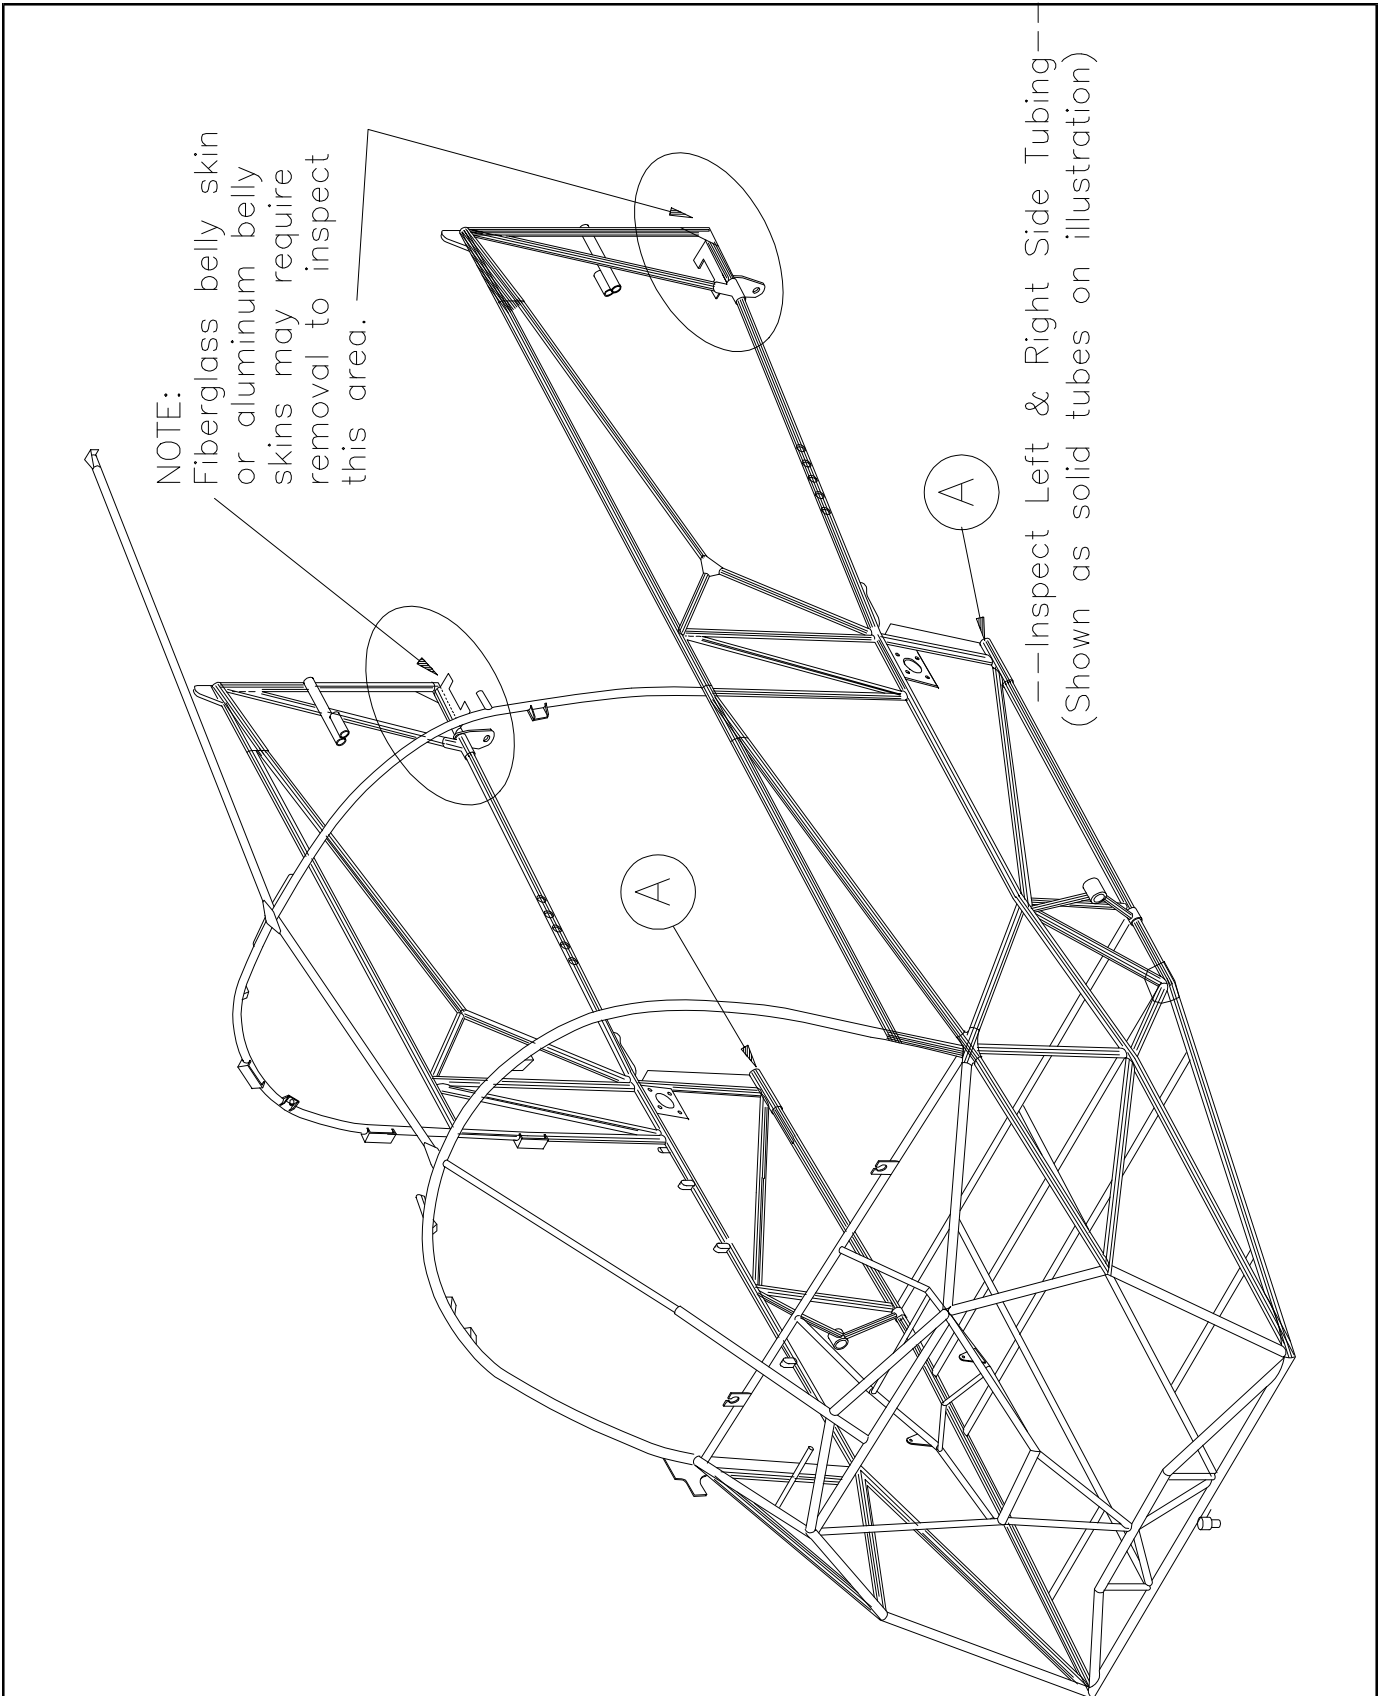
FIGURE S.B. M20-208-1

8. Visually inspect tubes and weld joints for signs of corrosion or moisture (ref. Fig. S.B. M20-208-1 for tubes to be inspected). Special attention should be directed to areas where the insulation was in direct contact with tubular structure members.
9. Use an awl, screwdriver or sharp punch to probe suspect tubes at points of insulation contact, and/or on bottom and lower ends of vertical structure, (where water most likely would be located, if present) to determine if tube wall has corroded from the inside. Probe along the entire length of horizontal tubes and around the circumference of any vertical or angled tube at lower end. Repair or replace any tube where internal corrosion is found. Refer to AC 43.13.1 (\*) for recommended testing and repair for welded tubes.

14. Cut safety wire that holds tension bolts. AN7H-17A, located at (A) Figure S.B. M20-208-1.
