SERVICE INSTRUCTION M20-117

SUBJECT: TO ADVISE OWNERS OF CORRECT ORIENTATION MOUNTING THE NOSE GEAR
“RETRACTING LINK” WHEN SERVICE AND MAINTENANCE IS PERFORMED ON ALL
MOONEY AIRCRAFT.

MODELS/ SN All M20 thru M20TN Series Aircraft
AFFECTED:

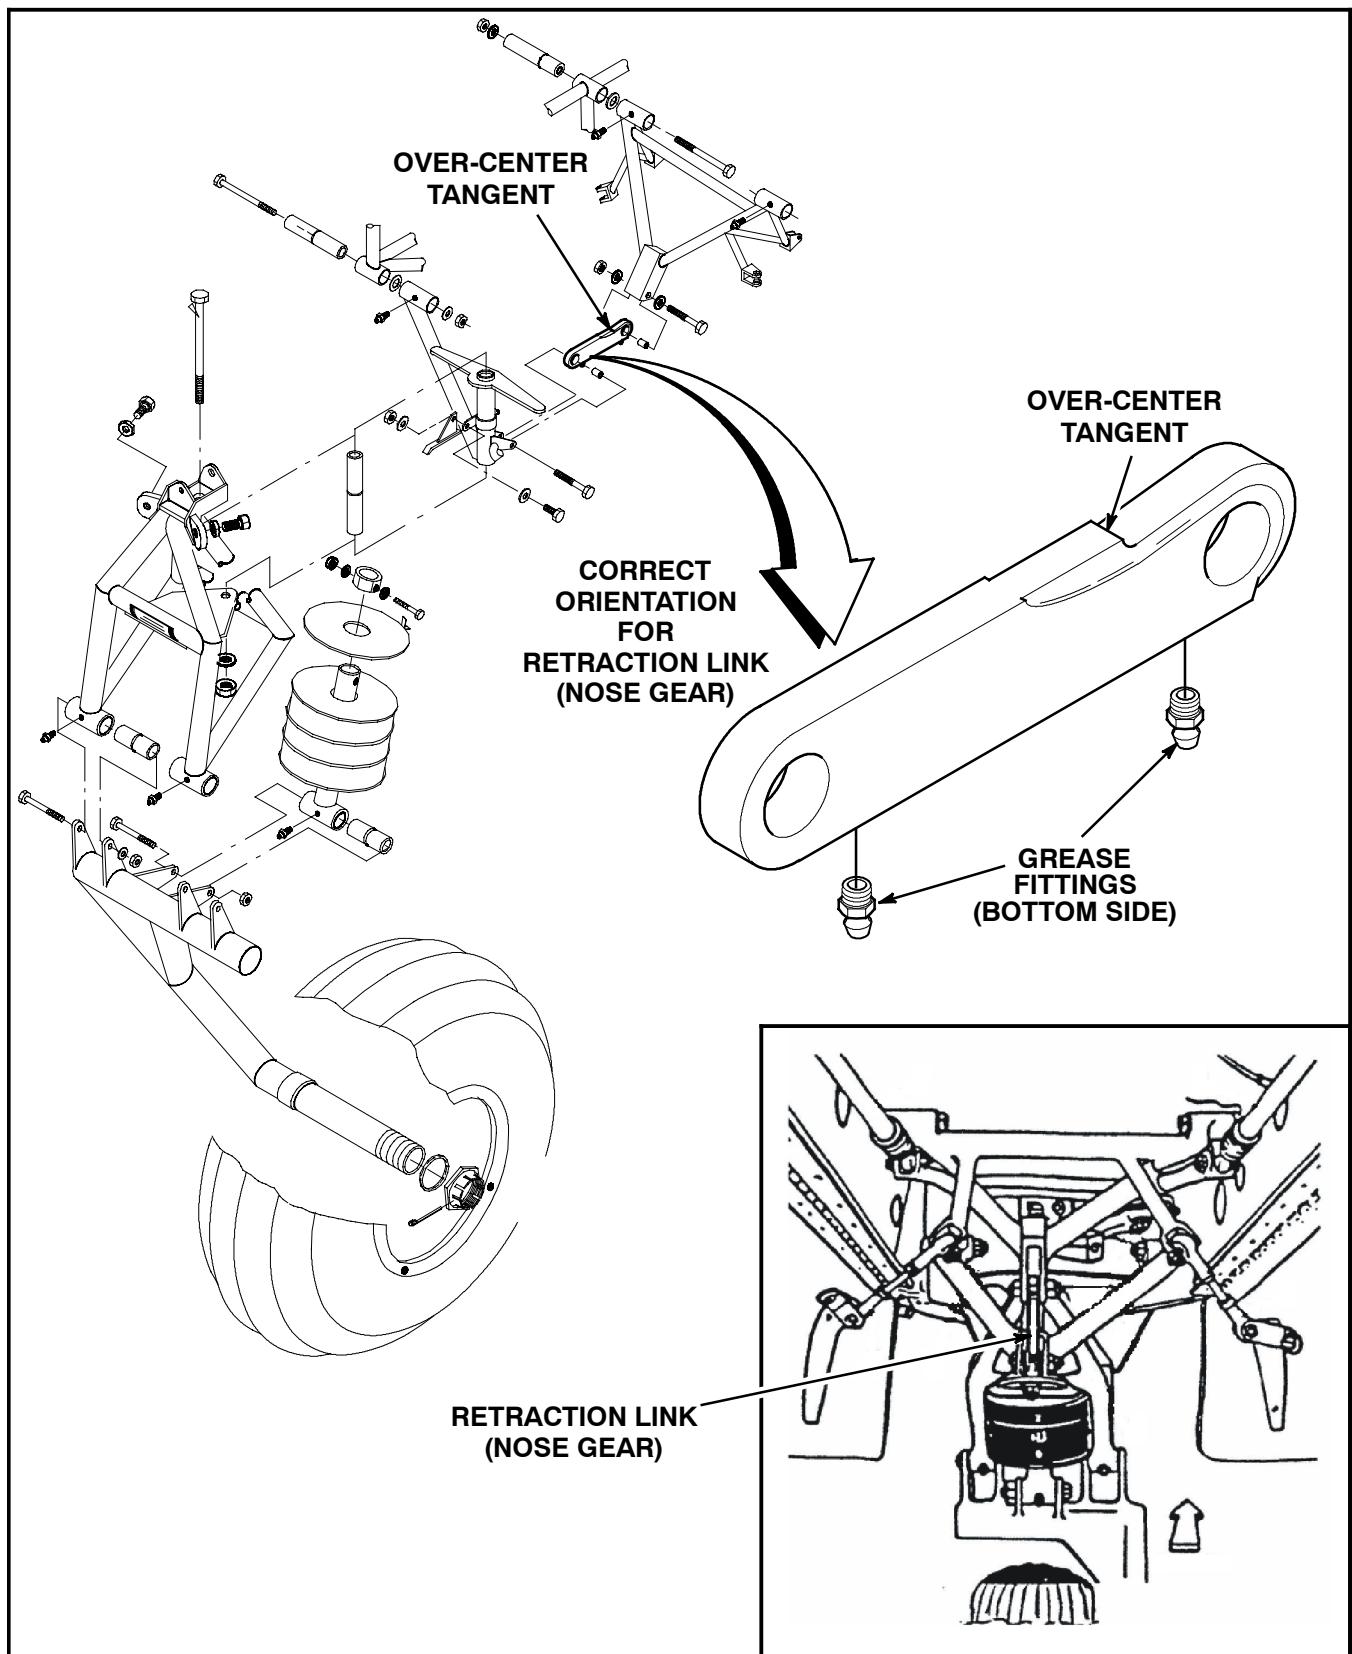
FIGURE 1 - ORIENTATION OF NOSE GEAR RETRACTION LINK

INTRODUCTION: There has been a reported instance in the field, that the nose gear “Retracting Link” was incorrectly installed (upside down). This incorrect installation caused the nose gear to collapse upon landing.

INSTRUCTIONS: This information is to clearly identify the correct orientation when installing the nose gear “Retracting Link” and orientation of the “over-center” tangent as shown in Figure 1.

Refer to the applicable Mooney Service Manual for nose gear rigging instructions.
