SUBJECT: M20J RAM AIR REMOVAL - RETROFIT

AFFECTED: M20J, S/N 24-0001 THRU 24-3153

COMPLIANCE: AT OWNERS DISCRETION

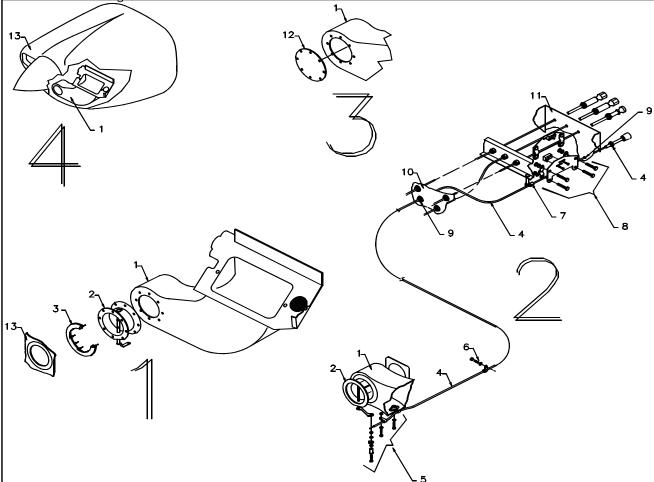
FIGURE SI-M20-93-1

INTRODUCTION: The development of the M20J induction system and cowling created a near opti-

mum design that has shown limited benefit from a ram air induction system. The components of the ram air are a source of maintenance over the life of the aircraft and therefore this retrofit is offered to those owners who may wish to remove the

1. Remove upper and lower cowling (13) per M20J Service and Maintenance Manual, No. 121, Section 71-11-00. Refer to Figure SI 93-1 during the accomplishment of the following instructions.

- 2. Refer to Section 1 of Figure SI 93-1. Locate the air induction assembly (1); then locate the ram air housing assembly, (2) (P/N 600360-501). Remove ram air control cable assembly from lower butterfly arm of ram air housing assembly.
- 3. Remove rivets from flange of ram air housing and air induction assembly (1) (12 each rivets). The rubber seal (3) for contact/sealing between ram air housing and lower cowling will come off with the housing.
- 4. Refer to Section 2 of Figure SI 93-1. Remove ram air control cable assembly (4) from lower arm of the ram air housing assembly. Remove ram air control cable assembly (4) from attachment points (5), (6) and (7) along cable.
- 5. Remove the Ram Air Warning Light Switch components from the control cable assembly, see components at point (8).

Be certain to remove the Ram Air Switch components (8), not the Landing Gear Warning switch components attached to throttle cable assembly.

- 8. Remove RAM AIR decal from console face in cockpit.
- 9. Plug hole in bottom of air induction assembly, at point (5), with existing AN3-3A bolt and washer.
- 10. Plug holes in console (11) and firewall (10). Firewall hole should be plugged with bolt, nut and washers (large OD) included in kit. PRO SEAL 700 or equivalent sealant should be used to seal this firewall fitting. Console hole (11) can be plugged with any style plug, owners discretion. A Heyco 2633 plug is included in kit.
- 11. Refer to Section 3 of Figure SI 93-1. Install cover, (12) (P/N 600355-003) to Air Induction Assembly (1) with MS20470AD3 rivets. Seal this cover assembly, after installation on to air induction assembly, with RTV-White Silicone sealant (not included in kit). Be certain all possible air passages are thoroughly sealed.

12. Refer to Section 4 of Figure SI 93-1. The lower cowling Ram Air Inlet hole must be sealed over. AC43-13 approved standard practice procedures, fiberglass repair methods, should be used to accomplish this action. Complete this procedure and paint cowling.
